Increasing Resilience of Coral Reefs and Coastal Communities in Olowalu, Maui, by Managing Land-Based Sediments

Final report prepared for:
Office of Habitat Conservation, Restoration Center
NOAA Fisheries | U.S. Department of Commerce

March 2025

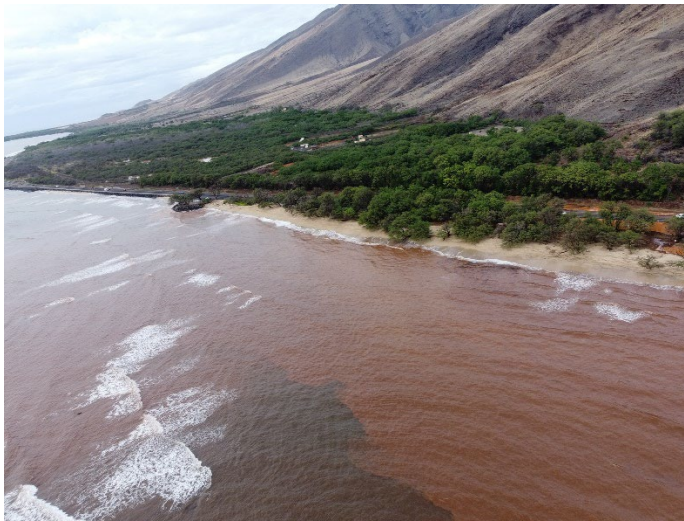
Figure 2: Ukumehame sedimentation event, December 2021.
Photo: John Brito, DLNR DOFAW

The eroded sediments smother reef organisms, prevent new coral from settling, and by clouding the water, reduce light available for coral and algae to photosynthesize. As a result, reef growth, structure, and function are compromised and reefs are less resilient to other stressors, including coral bleaching and other impacts of climate change. Sea level rise is already taking a toll on the shoreline at Olowalu, which is impacted by beach erosion and chronic flooding. Hardened, or “grey”, structures such as sea walls and concrete barriers have been installed to mitigate the erosion and flooding to the highway, however, these interventions perpetuate coastal and reef degradation by generating additional turbidity and reflective wave action.

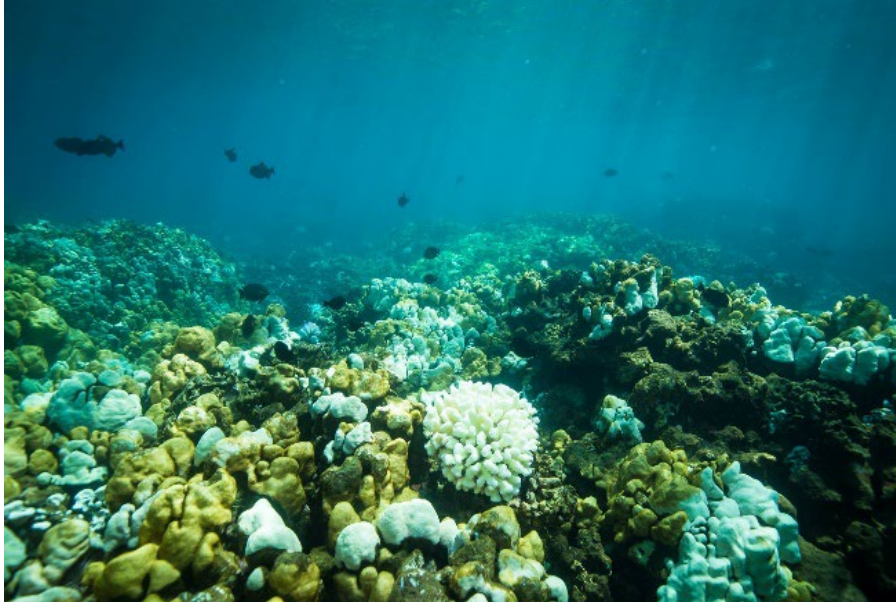
Figure 5: Coral bleaching in Olowalu, Maui. Photo: Drew Sulock

The Olowalu reef was heavily impacted by the 2015 marine heat wave and statewide coral bleaching event. Surveys show that Olowalu lost up to 45% of its live coral cover, decreasing vital habitat for reef-dependent organisms (DLNR DAR 2020; Figure 5).

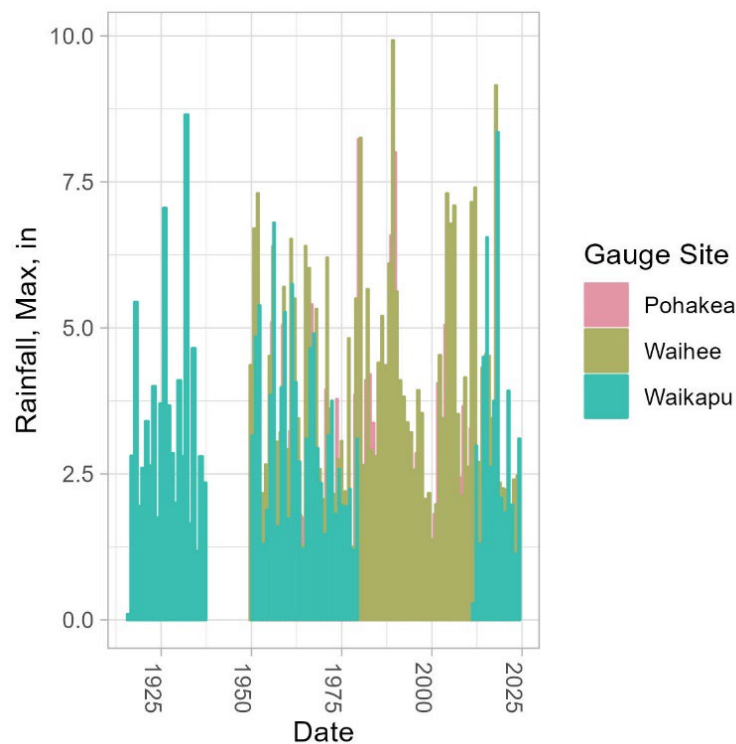
Figure 8: Rainfall amounts (in) recorded at Pohakea Bridge, Waihe'e, and Waikapū rainfall gauges from 1918-2024 showing max rainfall event per water year (as defined from October to September).

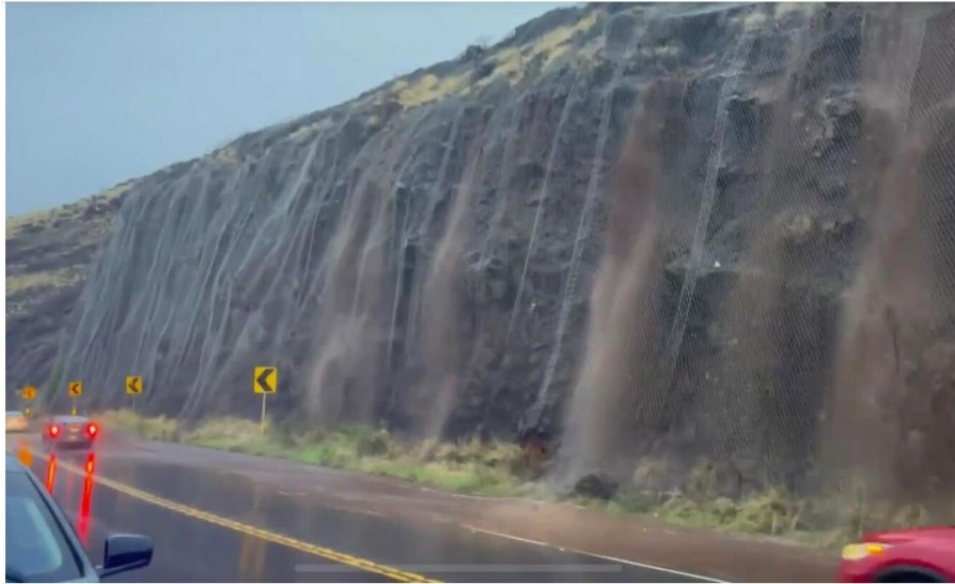
Figure 11: Overland flow on the Pali cliffs, an area that is not channelized, from the Dec. 5, 2021 storm. Photo: Maui News Now.

coming from many different points along the Pali, which would not have been predicted through this exercise (Figure 11).

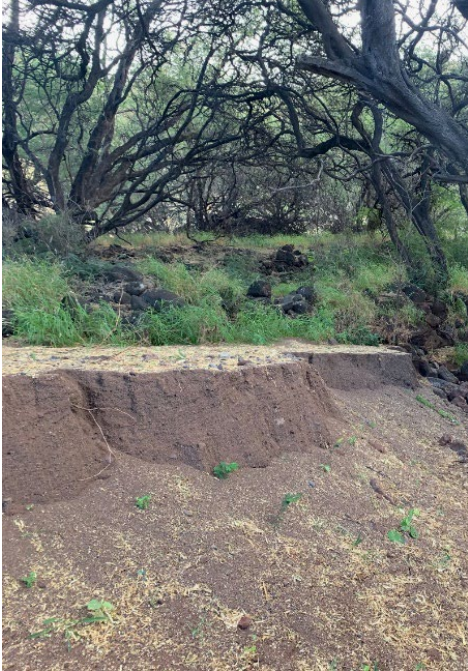
Figure 12: After the December 2021 storm, a 5-ft-high mound of fine sediment accumulated at the culvert in the Pali Trailhead parking lot. Photo: TNC.

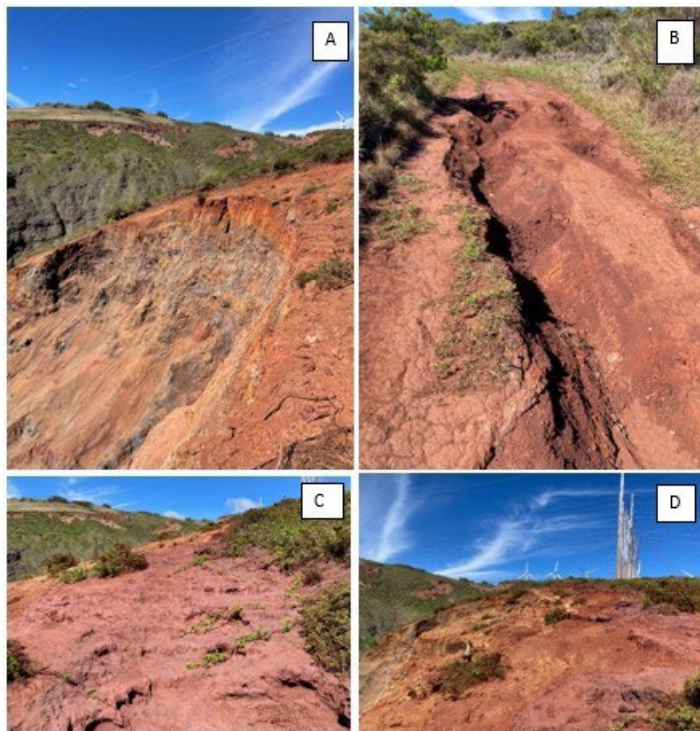
Figure 13: Erosion occurring at the top of Manawaipueo Gulch, on the east side of the gulch. Photo: TNC.

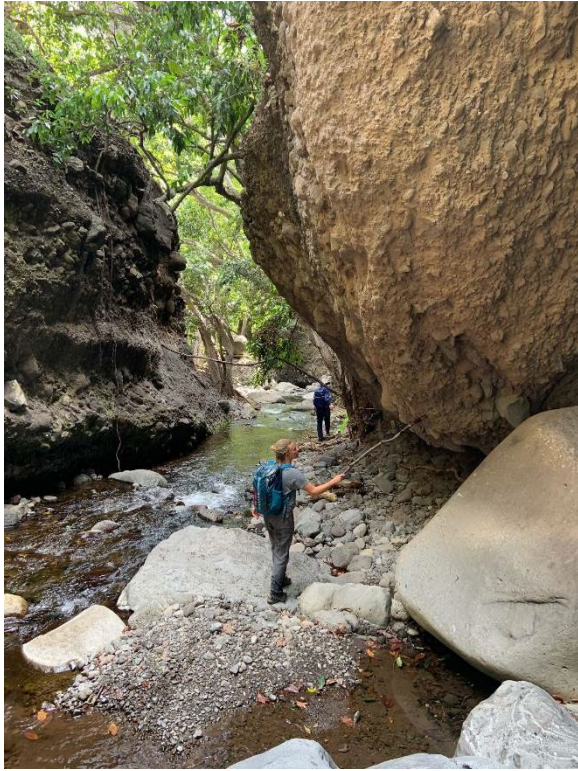
Figure 15: Older alluvial sediments from historical landslides on the banks of Ukumehame Stream.
Photo: TNC.

In this dataset, the areas identified included the sidewalls of Manawaipueo, Ukumehame, and Olowalu Valleys, some open areas in the alluvial plain that were former sugarcane and taro land, and patches in the headwaters of Olowalu Stream. The sidewalls of Ukumehame and Olowalu Streams were found to be made of older alluvial deposits, likely from former landslides and an aggregate of clastic sedimentary rock that has small pebbles entrained (Figure 14). These sidewalls are identified as bare and are unlikely to contain fine, silty sediments. The deposits in Manawaipueo Gulch, however, were found to be fine red ash-derived soils that are more erodible (Figure 15) (see the Soils section below).

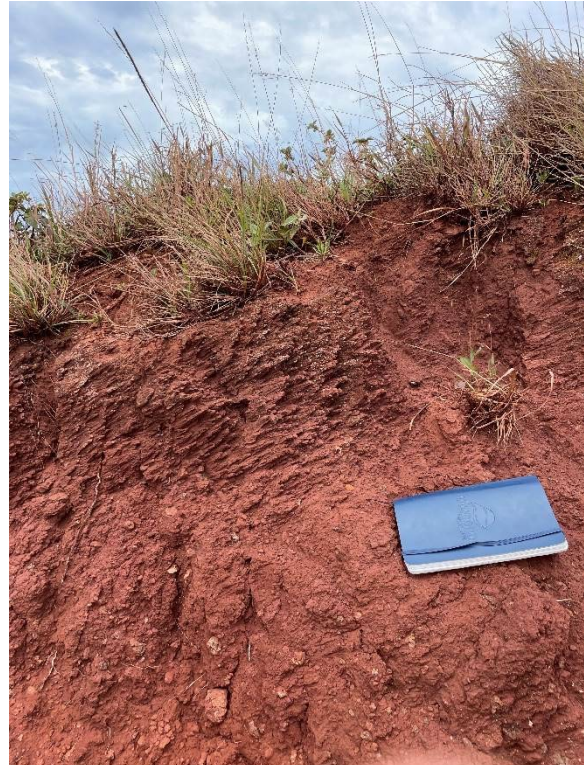
Figure 14: Manawaipueo Gulch sediments are fine and erodible. Photo: TNC.

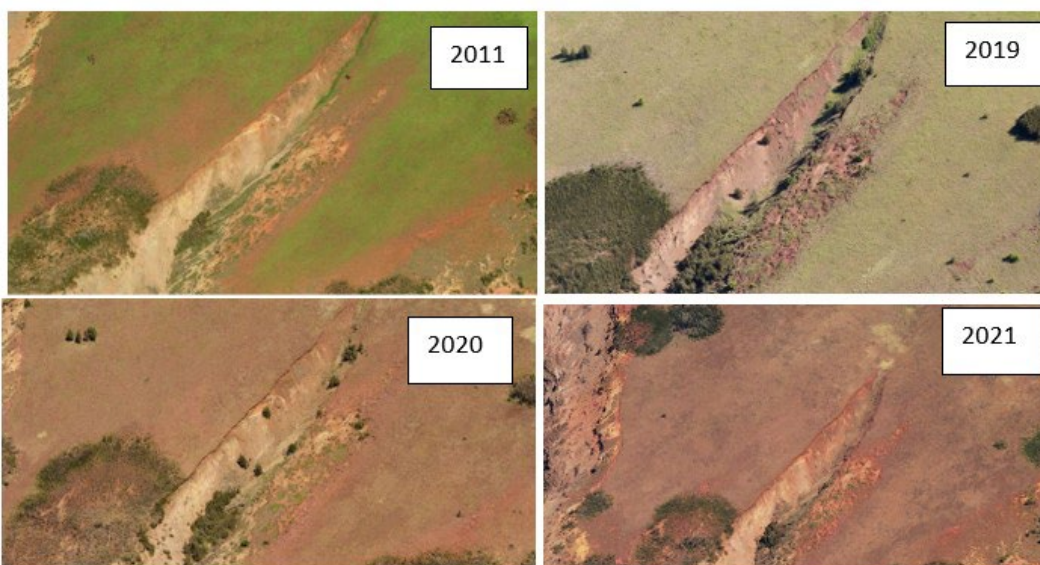
Figure 16: Pictometry photos documenting a time series for the headwaters of a tributary of Pāpalaua Stream.

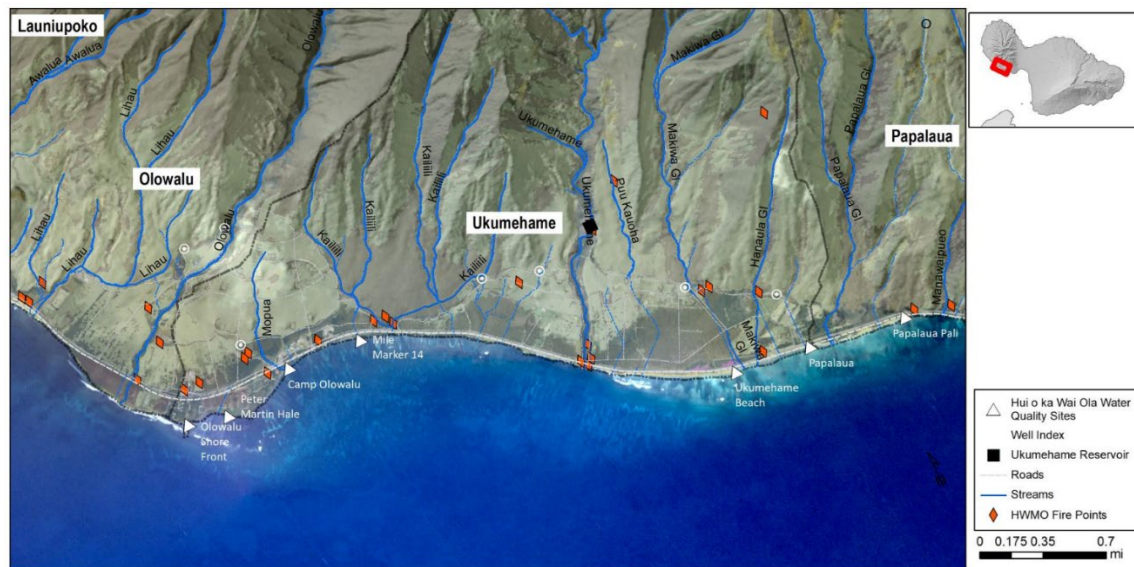
Map 11: Fires recorded in Olowalu and Ukumehame Ahupua'a 1999-2020.

We first investigated the known locations of historical fires using the database available from the Hawai'i Wildfire Management Organization (HWMO), as shown in Map 11. The largest known fires in Olowalu and Ukumehame from 1999-2020 are summarized in Table 6. The frequency of fires indicates that at least once or twice per decade the area has a 3,000⁺-ac fire. According to the Maui County Hazard Mitigation Plan Update (2020), the area has a comparatively low probability of ignition, but a high consequence for that ignition given its dry lowland areas, steep slopes, and lack of roads to control fire.

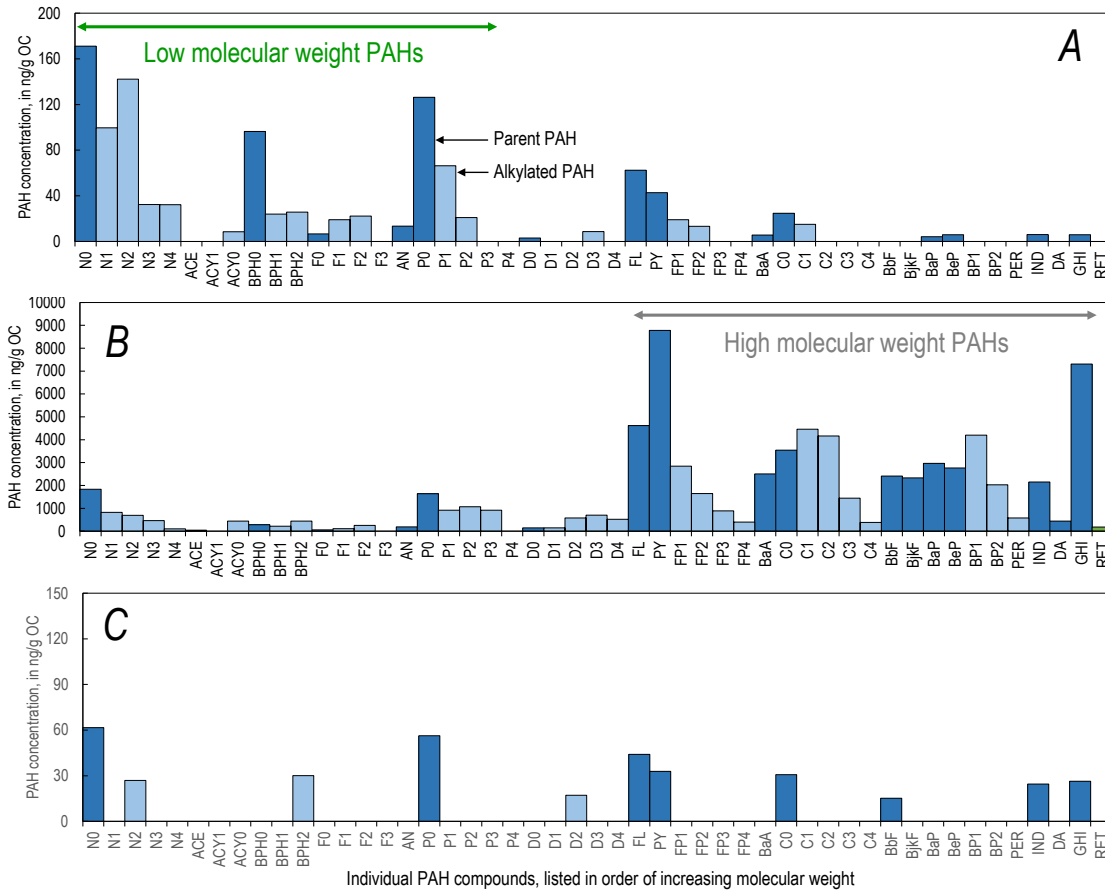
Figure 18: Distributions of parent (dark blue bars) and alkylated (light blue bars) PAH compounds normalized to the organic carbon content (OC) of the matrix listed in order of increasing molecular weight based on soils samples from. A) a retention basin above Pāpalaua Beach, B) roadside on the Pali, C) Kealaloloa Ridge at 570-ft elevation. Source: Renee Takesue, USGS.

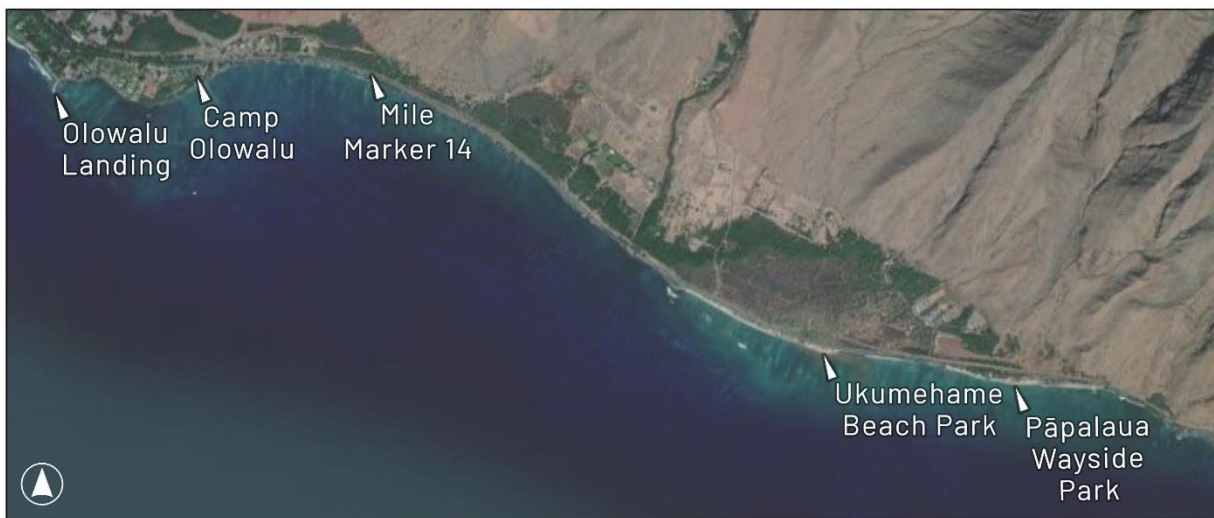
Figure 21: HOKWO sampling sites in the project area. Map: TNC

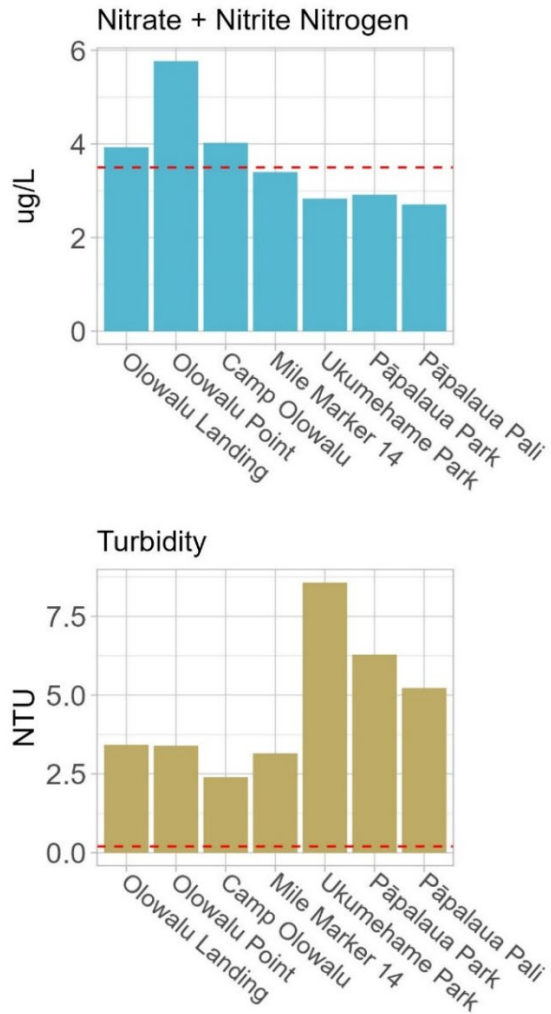
Figure 22: The geometric mean of nitrate concentrations (top) and the geometric mean of turbidity (bottom) across Olowalu reef sites from 2017-2024. In both figures, the dotted red line shows the state standard for that parameter.

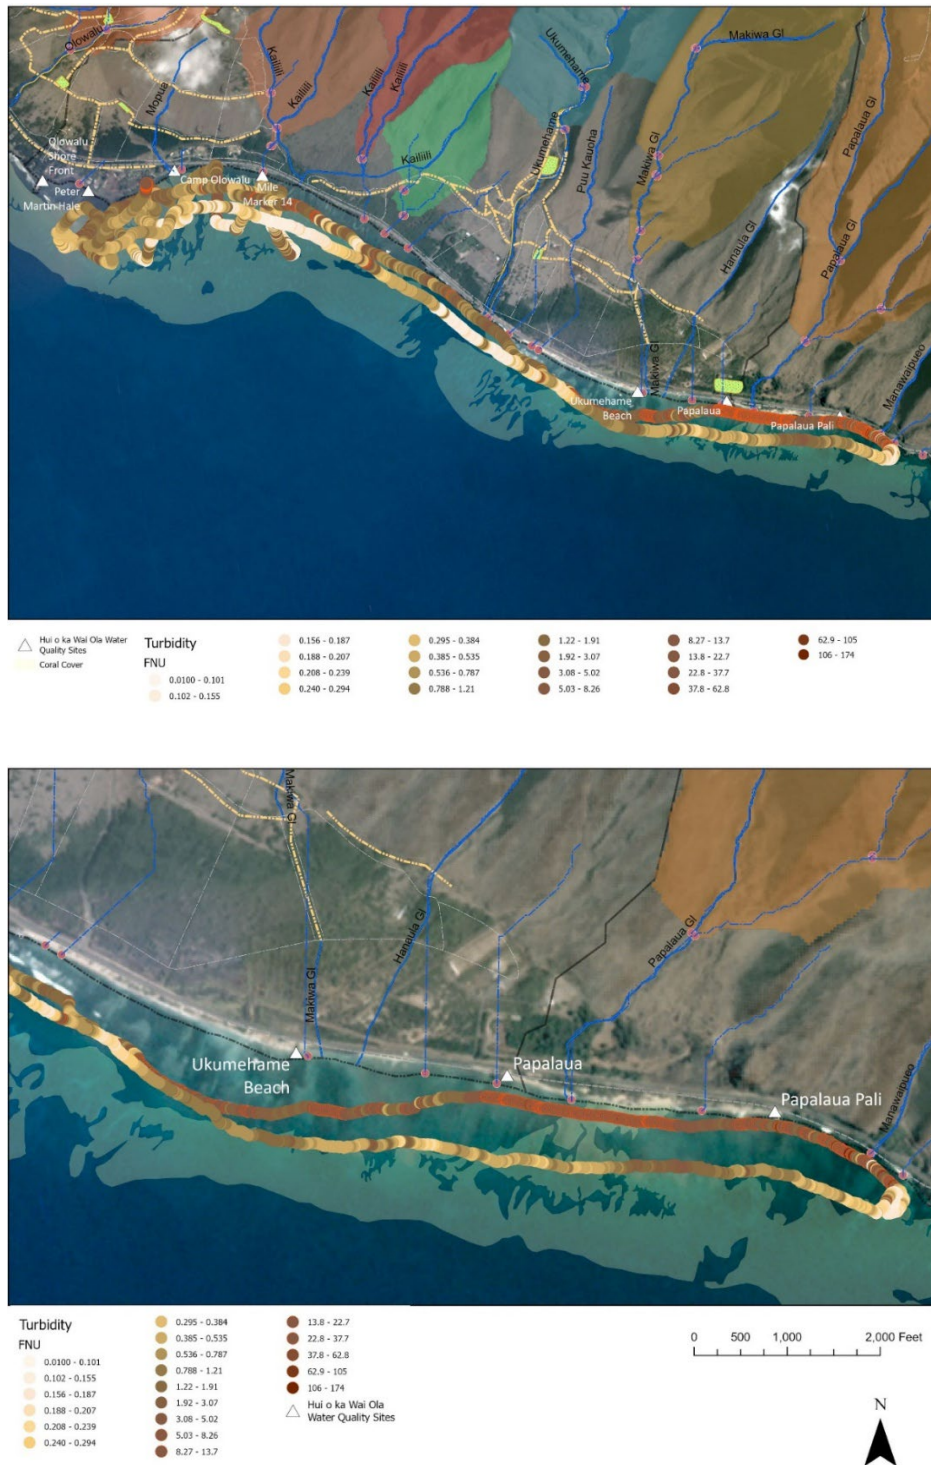
Figure 25: Measured turbidity along the shoreline (top) and a focused look at Pāpalaua Wayside Park (bottom). Places where turbidity was greater than 10 FNU (where coral mortality is likely, according to Tuttle et al) are highlighted in a red outline.

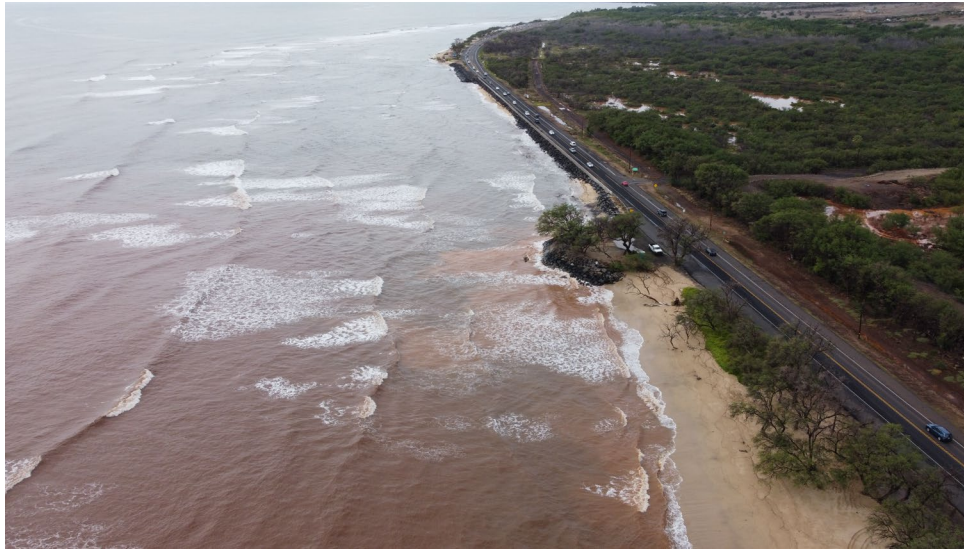
Figure 27: Aerial view of brown water event following heavy rain in December 2021. The Ukumehame wetland is also filled with water, as seen towards the upper right of the photo. Photo: Jon Brito, DLNR DOFAW.

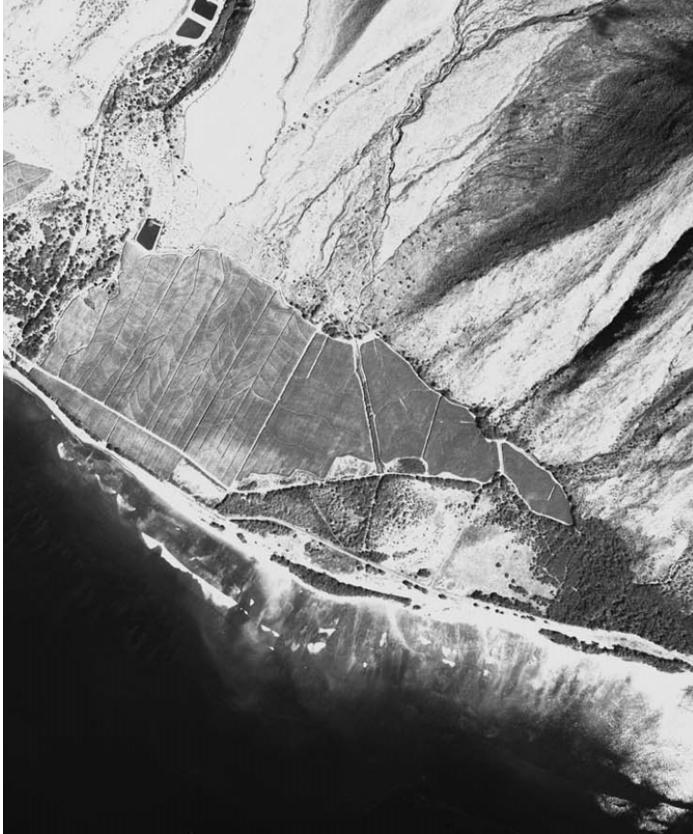
Figure 29: 1950 aerial image of the area to the right (Pali side) of Ukumehame (Photo: USGS EROS Archive)

The former path of the highway can be seen slightly inland from where it is today. Also visible are the water channels and a reservoir.

Today, the area adjacent to the highway is mostly dry and typically is vegetated by kiawe and other invasive trees. A wetland survey conducted by Vuich Environmental Consultants in 2005 describes similar findings when investigating potential wetlands within the project area. Boundaries from a 1998 wetland delineation of the Ukumehame Firing Range also describe man-made disturbances that altered vegetative cover and hydrologic conditions of the landscape when compared to aerial imagery from 1950 and 1962 (Figure 29; Figure 30) (NRCS, Hawai‘i National Guard, Oceanic Companies, Inc. 1998).

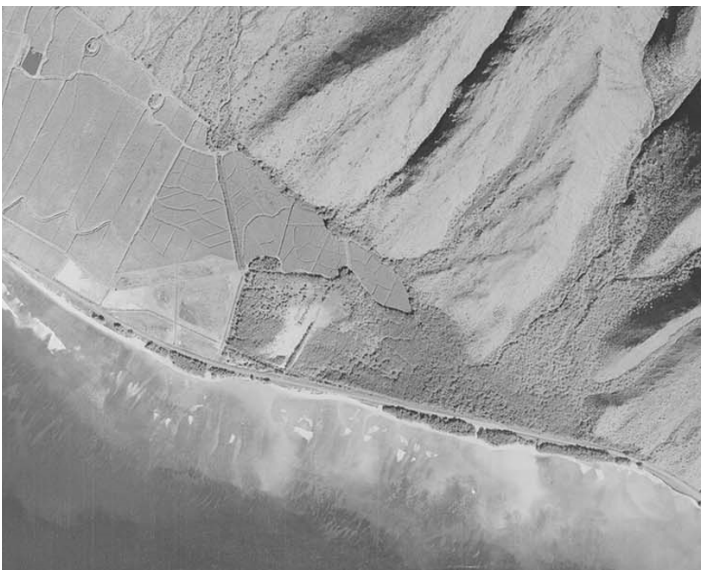
Figure 30: The same area as above. Using the upper left reservoir as reference, this 1962 photo shows the development of the current highway and the increase in size of the agricultural footprint. (Photo: USGS EROS Archive)

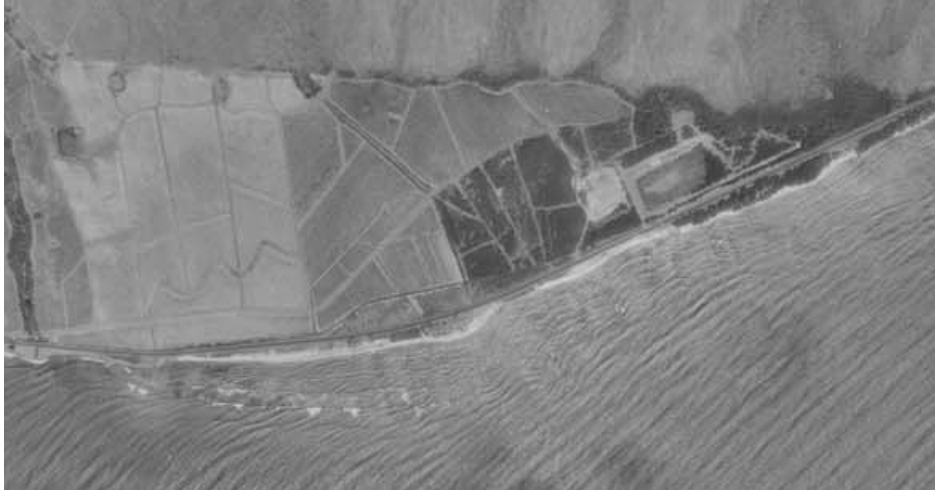
Figure 31: By 1975, Pāpalaua sediment retention basin had been built, and additional channelization of the undeveloped area around it continued (Photo: USGS EROS Archive)

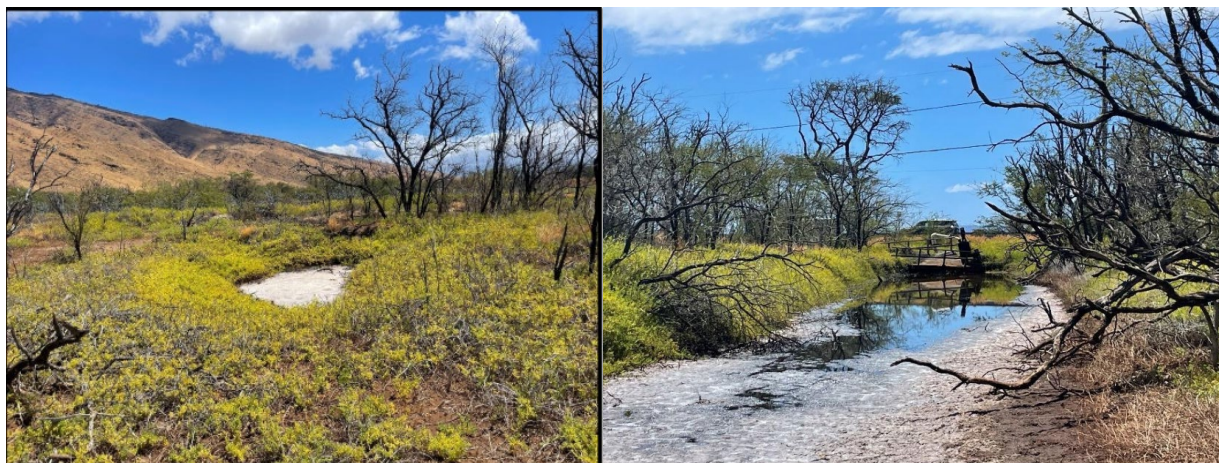
Figure 32: Current Ukumehame wetland (left) at TMK (2) 4-8-002:071 and drainage ditch (right) (2) 4-8-002:039. Photo: TNC.

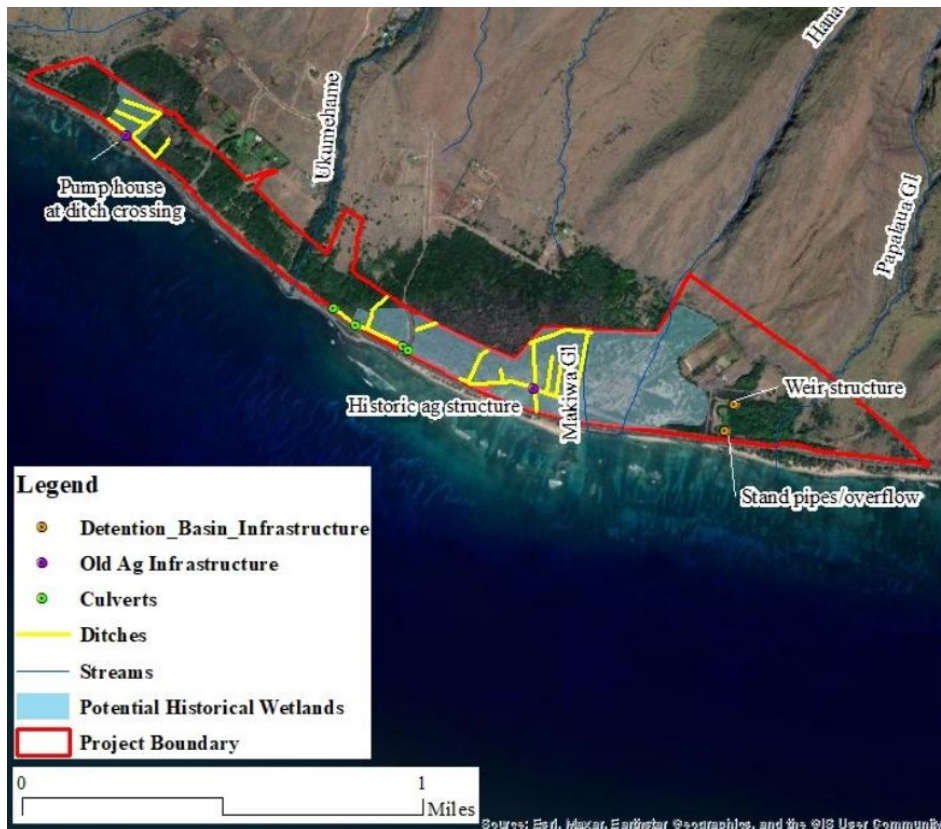
Figure 33: Potential historical wetlands as described by soils, vegetation, and hydrology and surveyed in 2023 by Maui Environmental Consulting.

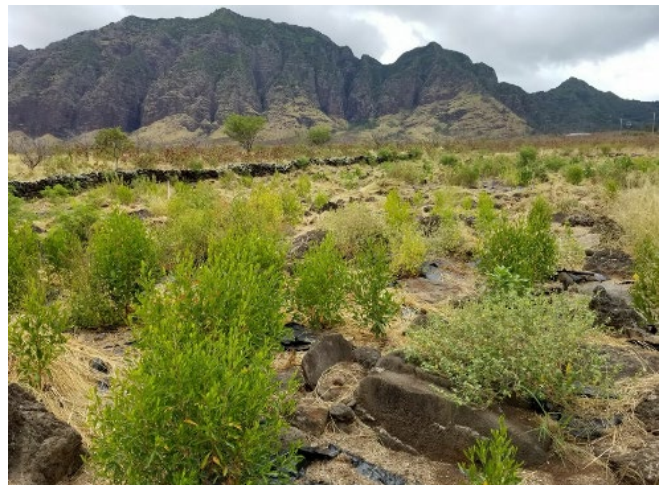
Figure 35: Greenbreak in Wai‘anae, O‘ahu. Photo: Wai‘anae Mountains Watershed Partnership

Green firebreaks could be suitable for any lands in the project area where ungulates are not present. Irrigation is required for establishment.

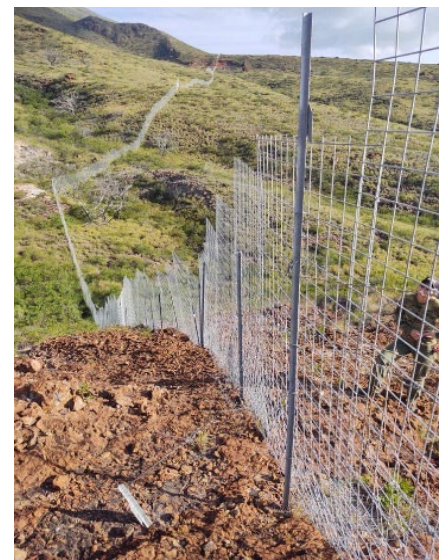
Figure 36: Ungulate proof fence. Photo: MKWP

Potential Partners: The proposed Ukumehame fencing by DOFAW and MKWP will prevent pigs and goats from encroaching further into the Ukumehame Watershed and will strategically contain and prevent Axis deer from their expansion along a southern route from Central Maui into West Maui.

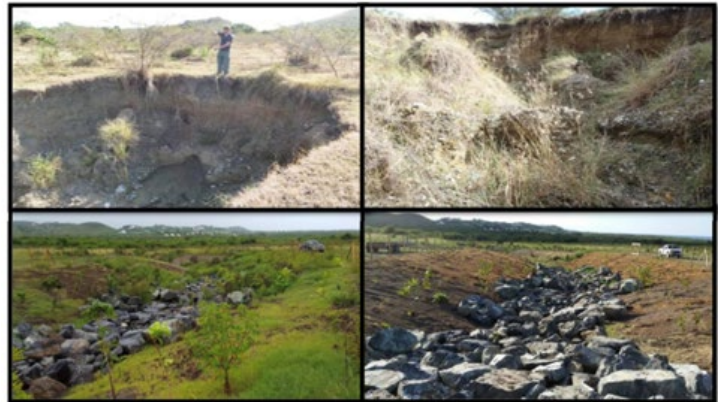
Figure 40: Head cut stabilization project in Pohakea. Photo: MNMRC

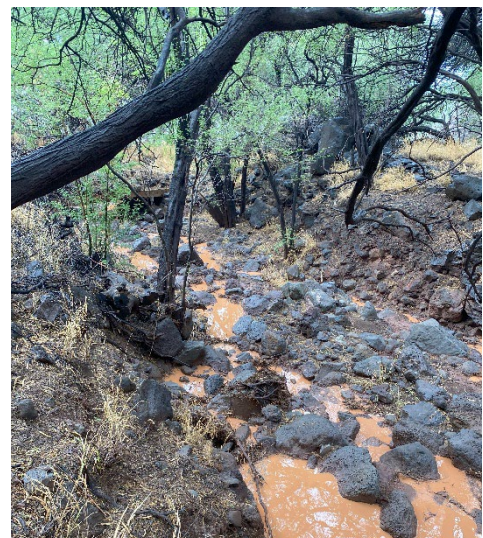
Figure 41: Sediment flowing down Manawaipueo Gulch, January 2024. Photo: TNC

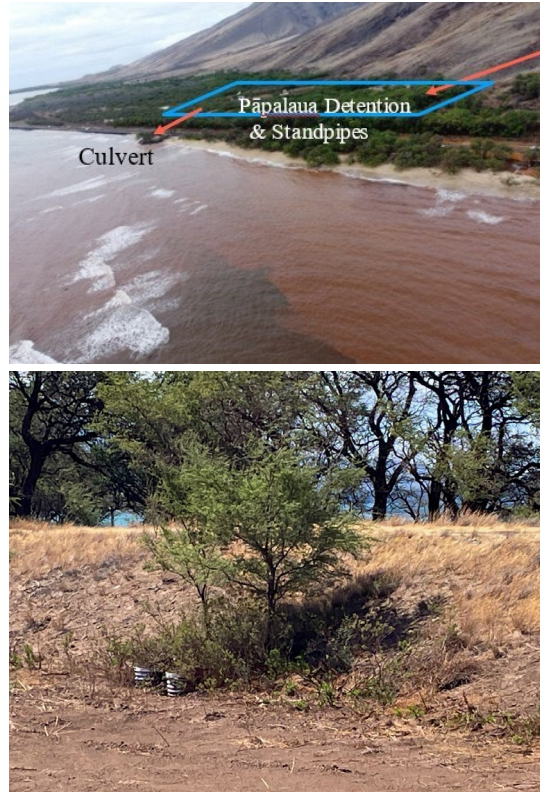
Figure 44: Pāpalaua Detention Basin and culvert locations. Photo: DOFAW

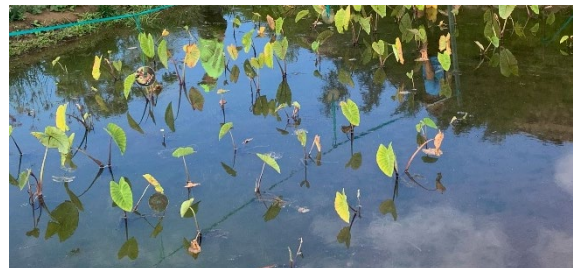
Figure 46: Restoration of lo‘i at Kipuka Olowalu. Photo: TNC

Intervention: Restoring traditional flooded-field terraced agriculture can increase flood mitigation, aquifer recharge, sediment retention, nutrient uptake, and the supply of culturally important food crops such as kalo. Lo‘i kalo, a type of traditional Hawaiian agriculture, use a series of terraces in which stream water is diverted through ‘auwai (ditches) and used to flood the fields before being returned to the stream. These multi-tiered wetlands have the potential to retain sediments and take up nutrients at a rate higher than conventional large-scale retention basins (Hogan 2007). Prior to 1900, it is estimated that 10,000 ac of kalo was in cultivation in Hawai‘i using lo‘i. Māla, garden, plantation, patch or cultivated fields are also important for land and soils management. In the dry, sunny climate and rocky soils of the project area, ‘uala, or sweet potato, was in widespread cultivation.

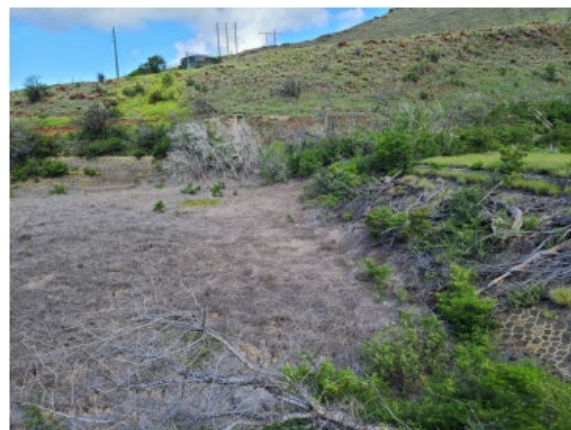
Figure 48: Ukumehame Reservoir 2. Photo: DLNR, Dam Safety Program

Intervention: The Ukumehame Reservoirs are prime candidates for restoration projects to capture sediment. Projects could take the form of a wetland, lo‘i kalo, bioretention micro basin, or constructed wetland. The off-stream Ukumehame Reservoirs 2 and 3 are earthen embankment dams constructed side-by-side along the western slope of Ukumehame Gulch that take water from the stream during high flows. The reservoirs are 770 ft in length and 29 ft high (Falinski and Penn 2018). In 2017, one of the reservoirs was decommissioned due to a leak of more than 100 gallons per minute and regulatory challenges. However, the area still holds water some of the time and is used as a refuge for waterbirds.

Considerations: An engineering assessment of the basins to increase their function could inform decision-making.

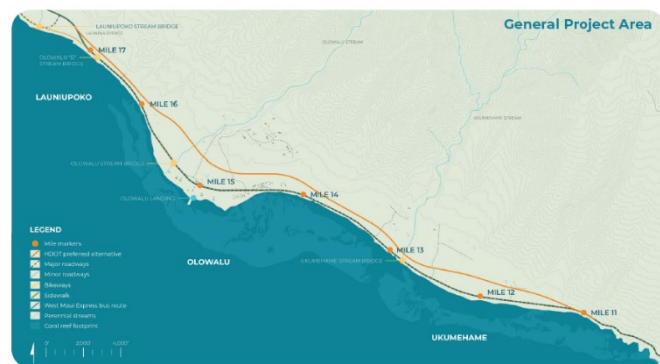
Figure 49: Olowalu: The Road to Resilience project area map. Source: UH CDC

In partnership with the University of Hawai‘i’s Community Design Center (UH CDC), we are engaging the community through “Olowalu: The Road to Resilience” to develop a vision for the coastal corridor when the highway is moved. Through a series of interactive in-person and virtual meetings, our goal is to identify nature-based and biocultural interventions that can be implemented in tandem with the road realignment and other coastal planning processes in the region. Based on the results of the visioning, analysis of current conditions, sea level rise

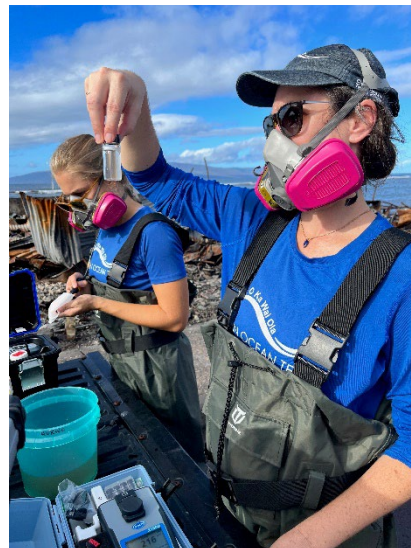
Figure 51: HOKWO water quality testing. Photo: Tova Callender

HOKWO volunteers conduct water quality monitoring on a regular schedule at fixed sites including where sediment runoff is a primary concern. Parameters studied are temperature, salinity, dissolved oxygen, pH, turbidity, and nutrients. Sample collection occurs at the same place and approximately the same time and from the same pool of water each time. When collecting water samples, three samples are collected and used for turbidity, nutrients, and physical measurements. Turbidity samples are analyzed in the field with a Hach 2100Q turbidimeter and read three times for redundancy. Nutrient samples are filtered into acid-washed bottles, frozen, and shipped to the SOEST Laboratory for Analytical Biochemistry for analysis. Physical measurements are taken on site using field Hach HQ40d multimeter and intelliCAL DO, salinity, and pH probes. Data is carefully recorded on datasheets and verified by team leads. HOKWO data, demonstrates the tight relationship between groundwater and nutrient delivery and is available for free upon request at huiokawaiola.com.
